The fire resistance performance of a specimen of a non-loadbearing, partition wall assembly tested in accordance with BS 476: Part 22: 1987, Clause 5

411164

Enviroboards Ltd

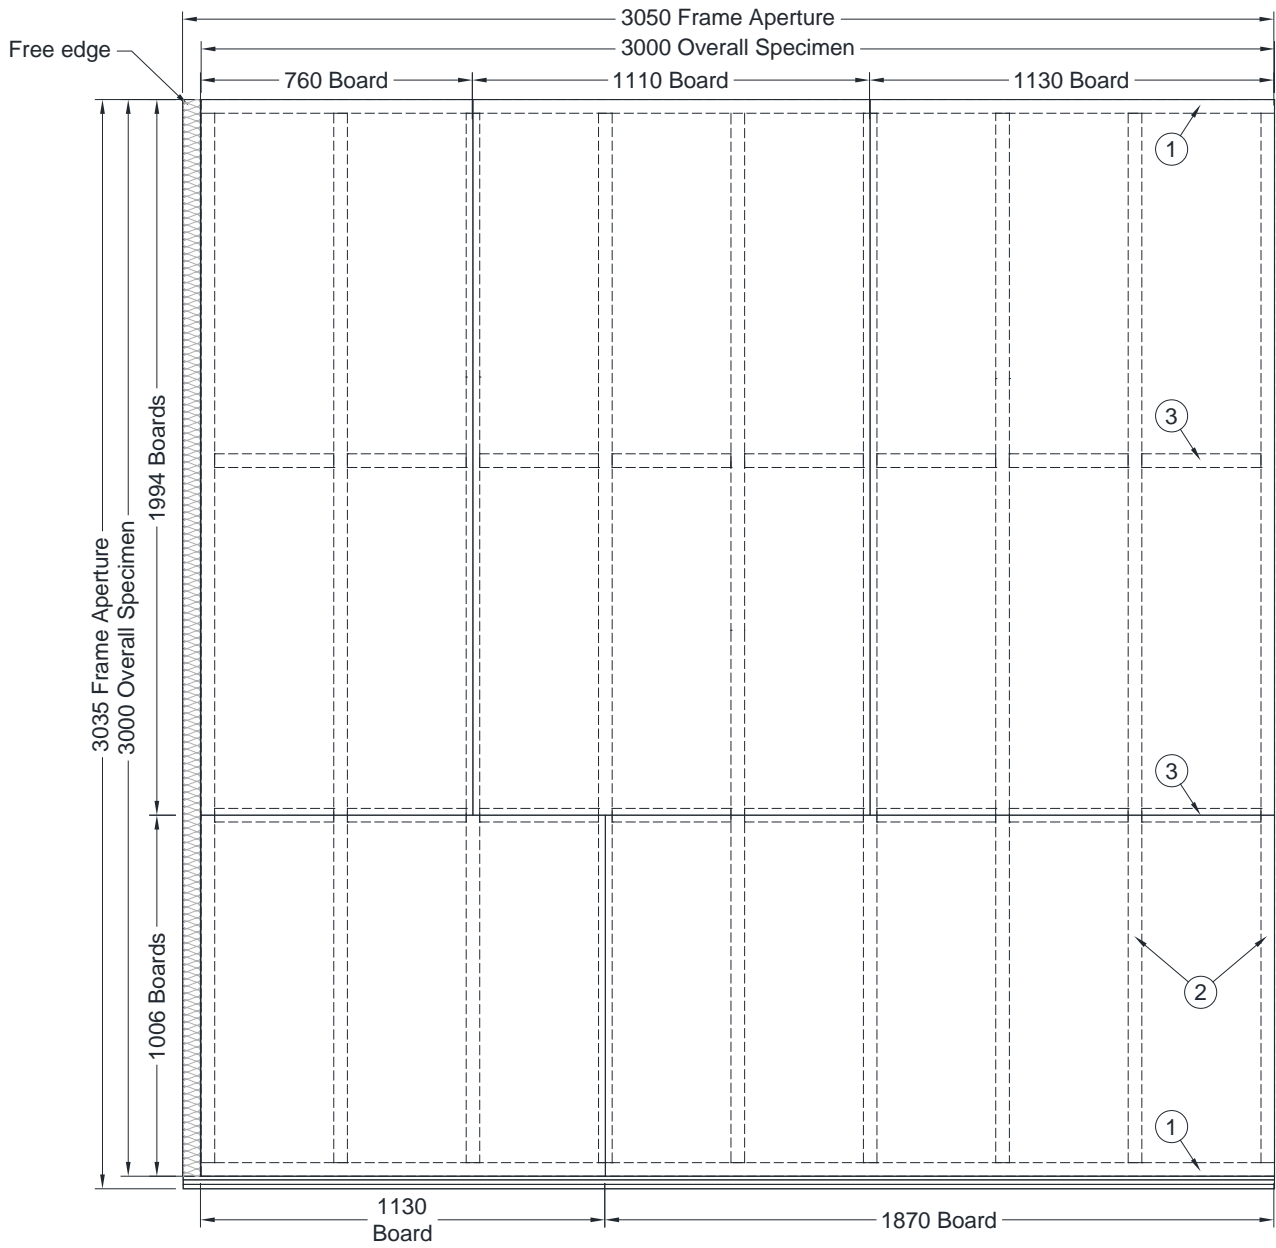
Figure 2 – General Elevation of Exposed Face

GENERAL ELEVATION
OF EXPOSED FACE

<u>Item</u>	<u>Description</u>
5. Cladding Boards	
Manufactured for	: Enviroboards Ltd
Reference	: 9 mm Fireboard
Type	: MgO based board
Thickness	: 9 mm
Density	: 1150 kg/m ³ , stated
Fixing methods	: Fitted in a single layer on each face and through screwed to the framework sections. All joints between boards and connections to the framework were sealed with jointing sealant (Item 6). For boards layout see Figures 1 & 2.
Fixings

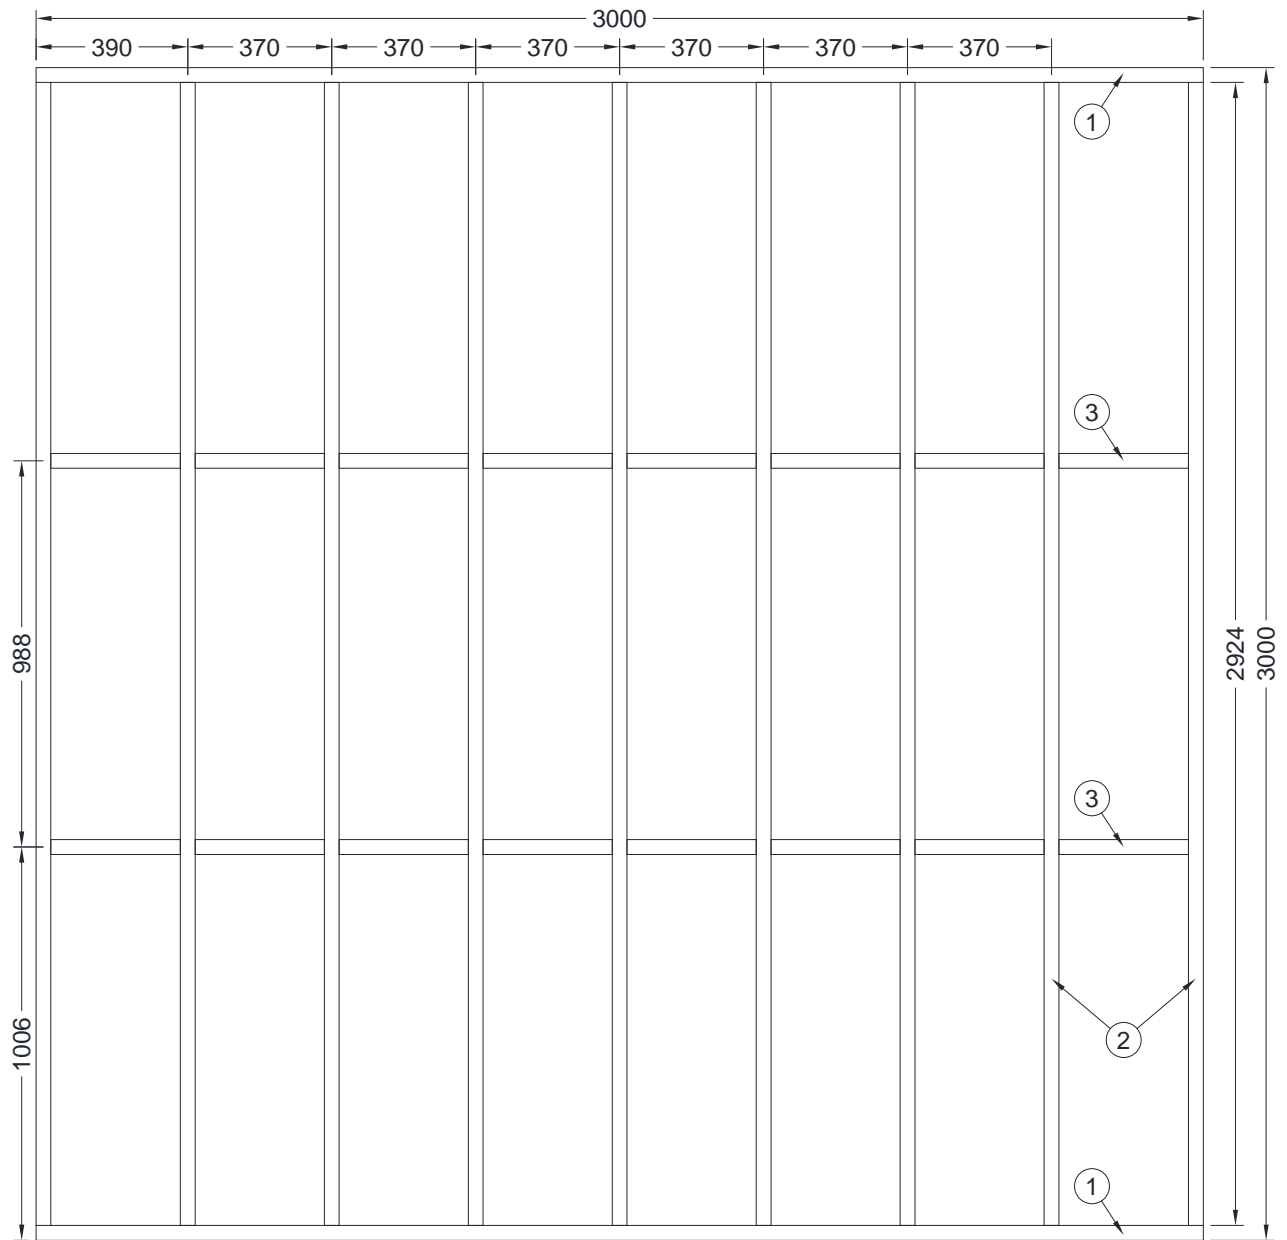
Figure 3 – General Elevation of the Framework (Items 1 to 3)

GENERAL ELEVATION
OF FRAMEWORK

<u>Item</u>	<u>Description</u>
1. Top & Bottom Rail	
Material	: C16 grade general commercial softwood
Overall sizes	: 38 mm wide by 89 mm deep x 3000 mm long. See Figure 3 for layout configuration.
Fixing method to the restraint frame	: Through fixed to lining of restraint frame across the head and base with 7.5 mm dia. by 100 mm long screws at 580 mm centres.

2. Studs	
Material	: C16 grade general commercial softwood
Overall sizes	: 38 mm wide by 89 mm deep x 3000 mm long. See Figure 3 for layout configuration.
Fixing method to the restraint frame	: Through fixed to lining of restraint frame across one vertical edge with 7.5 mm dia. by 100 mm long screws at 580 mm centres.
Fixing method to the rails	: Spaced at 370 mm centres, butt jointed with top and bottom rails (item 1) and fixed with screws through the top & bottom rails
Fixings

v. quantity	: 2 off per stud at each end
3. Noggins	
Material	: C16 grade general commercial softwood
Overall sizes	: 38 mm wide by 89 mm deep x 3000 mm long. See Figure 3 for layout configuration.
Fixing method to studs	: Screw fixed to studs at positions shown on Figure 3.
Fixings

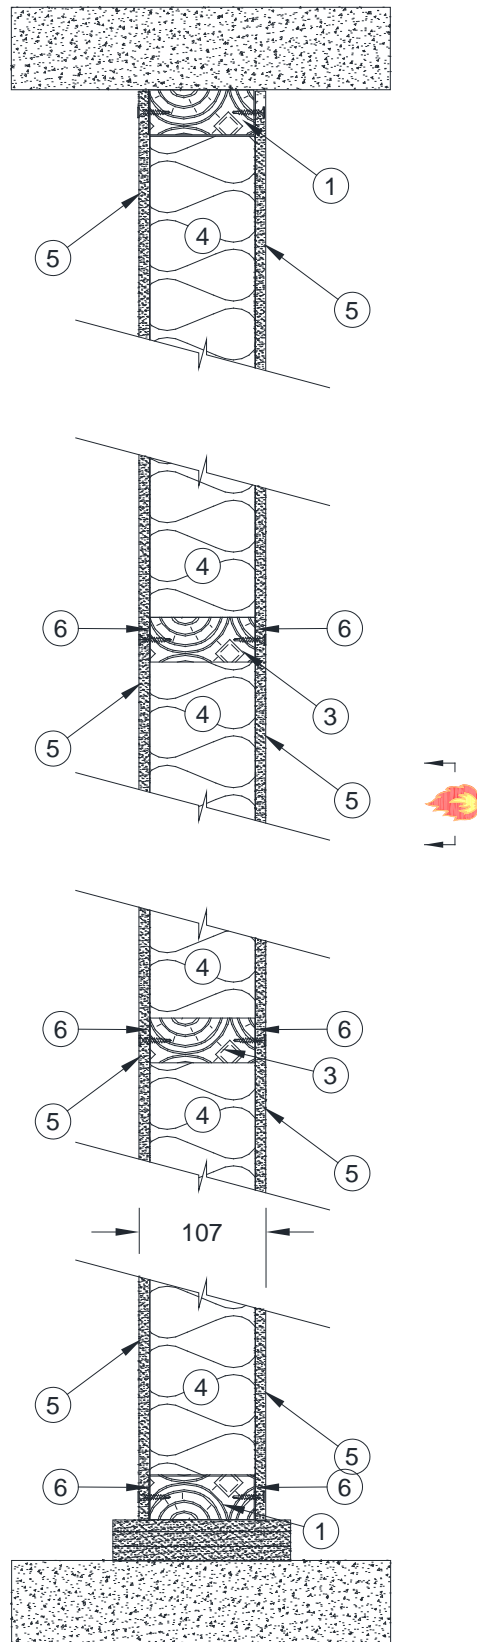
Figure 4 – Section Through A-A

SECTION THROUGH A-A

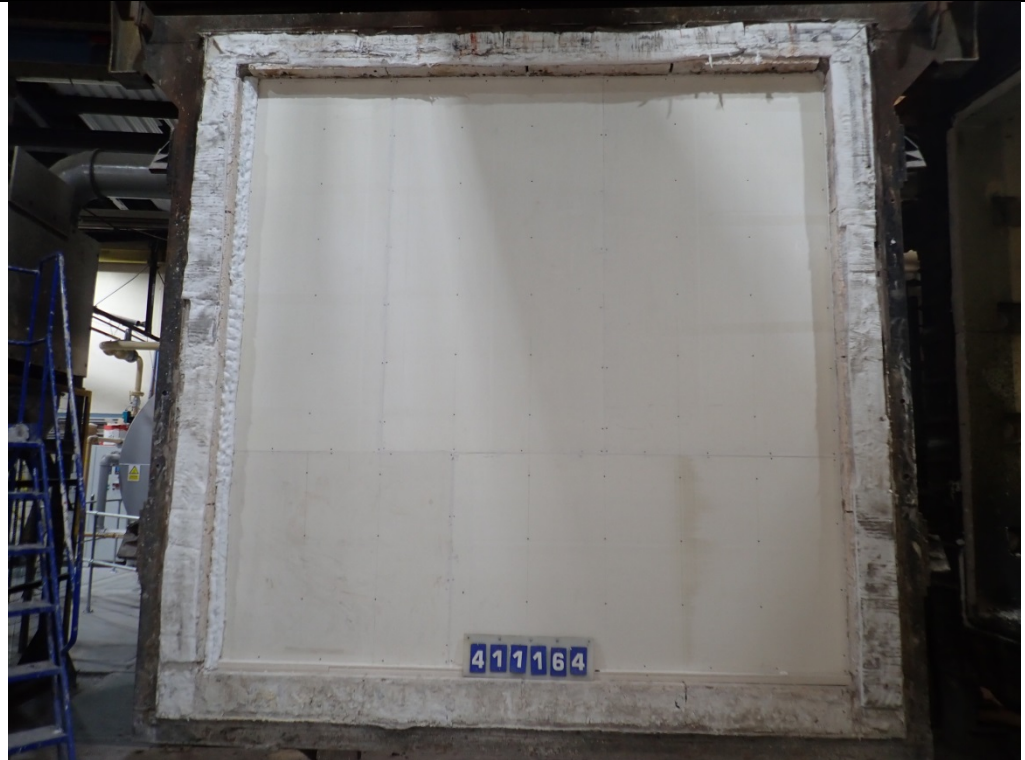
The exposed face of the test specimen prior to testing

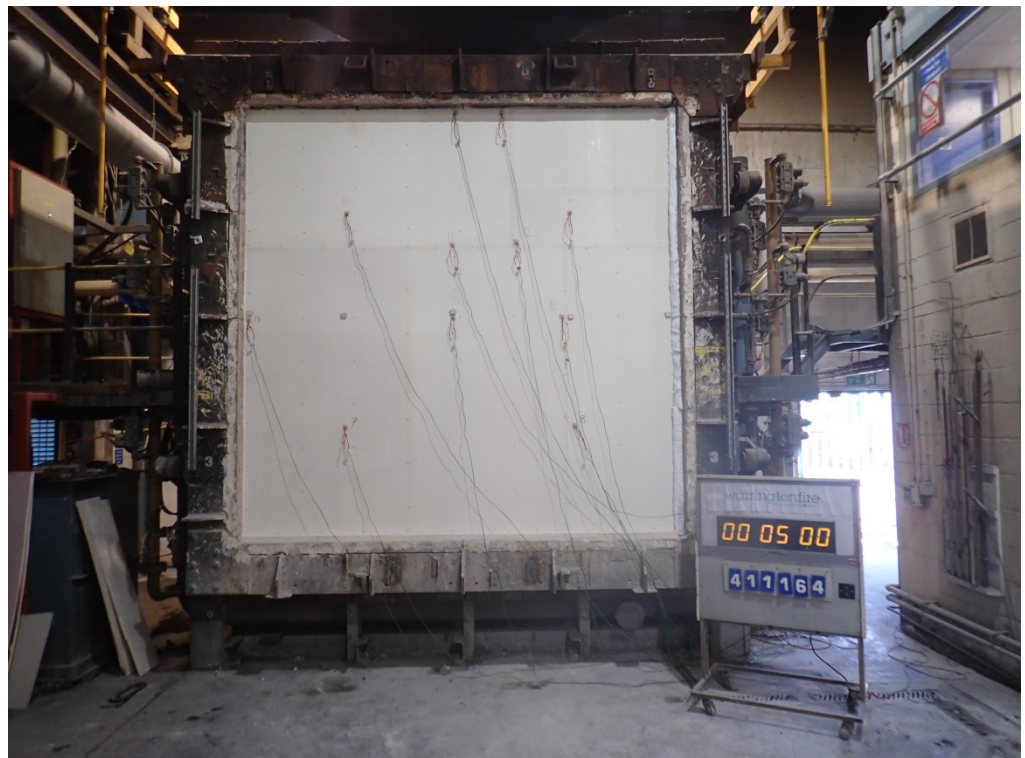
The unexposed face of the test specimen after 5 minutes of testing

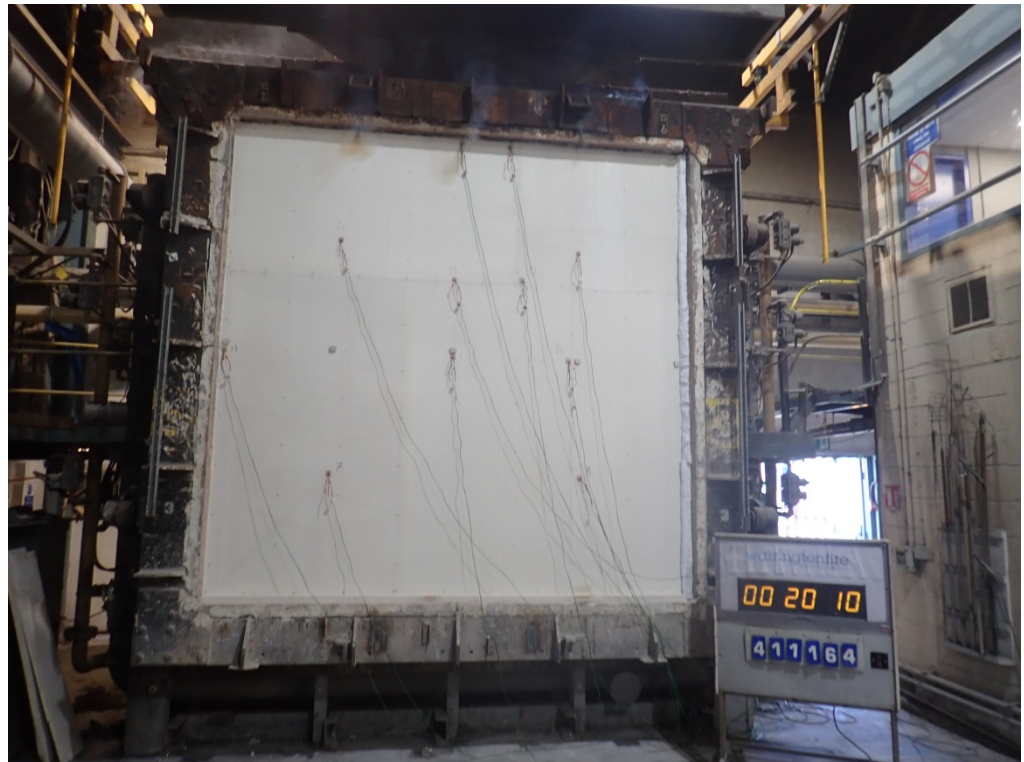
The unexposed face of the test specimen after 20 minutes of testing

Time		All observations are from the unexposed face unless noted otherwise.
mins	secs	
00	00	The test commences.
08	04	Slight smoke/steam release from the head of the specimen at the joint position, and one quarter in from fixed edge.
12	13	Light brown discolouration at the base of the specimen on the right hand side of the right vertical joint.
16	12	Light brown discolouration at the head mid width and ¼ in from the fixed edge (at smoke release locations).
16	50	Brown liquid discharging from horizontal joint approximately 30 mm in from fixed edge.
20	58	When viewed from the exposed face vertical joints are opening. The boards at the bottom left of the specimen have parted but not detached.
23	39	Discoloration is intensifying at smoke release location, at the head of the specimen one quarter in from fixed edge.
26	09	Intermittent crackling sounds can be heard.
28	07	Smoke/steam release is sustained.

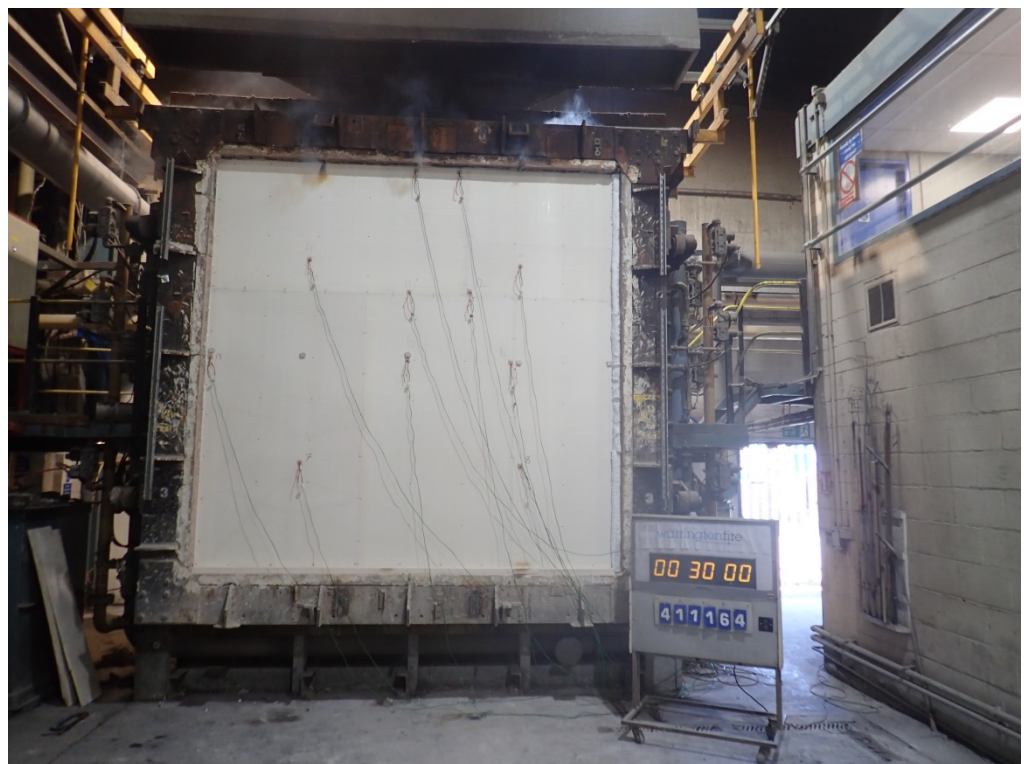
The unexposed face of the test specimen after 30 minutes of testing

31	38	When viewed from the exposed face, joints are widening. Flaming can be seen at joint location. Horizontal crack formed across the full width of the top right board.
42	41	When viewed from the exposed face, joints continue to widen and flaming is sustained. Small cracks are forming in all boards.
45	20	No significant visible change.
48	39	Discoloration at the base to the right of the right vertical joint is darkening.
54	53	When viewed from the exposed face, the cracks within the panels are widening. Panels have detached.
60	00	Specimen continues to satisfy integrity performance criteria.
62	08	Dark patch at the head is growing. (No glowing visible).
64	40	When viewed from the exposed face, no significant visible change.
67	00	Test discontinued at client's request.

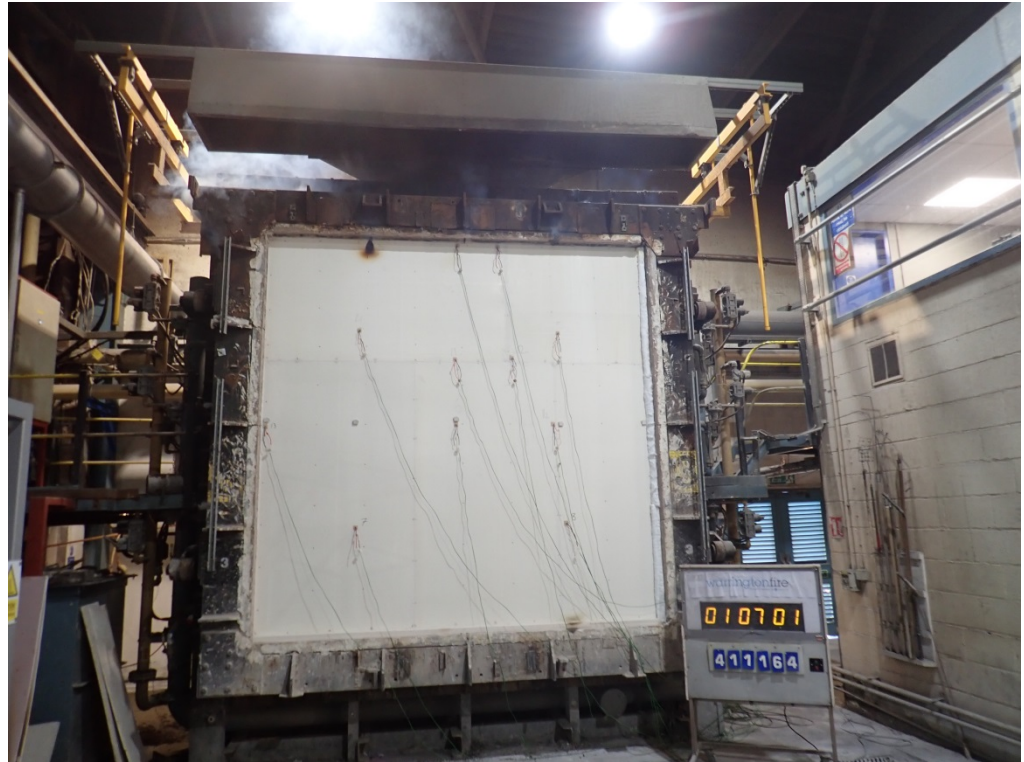
The unexposed face of the test specimen after 67 minutes of testing

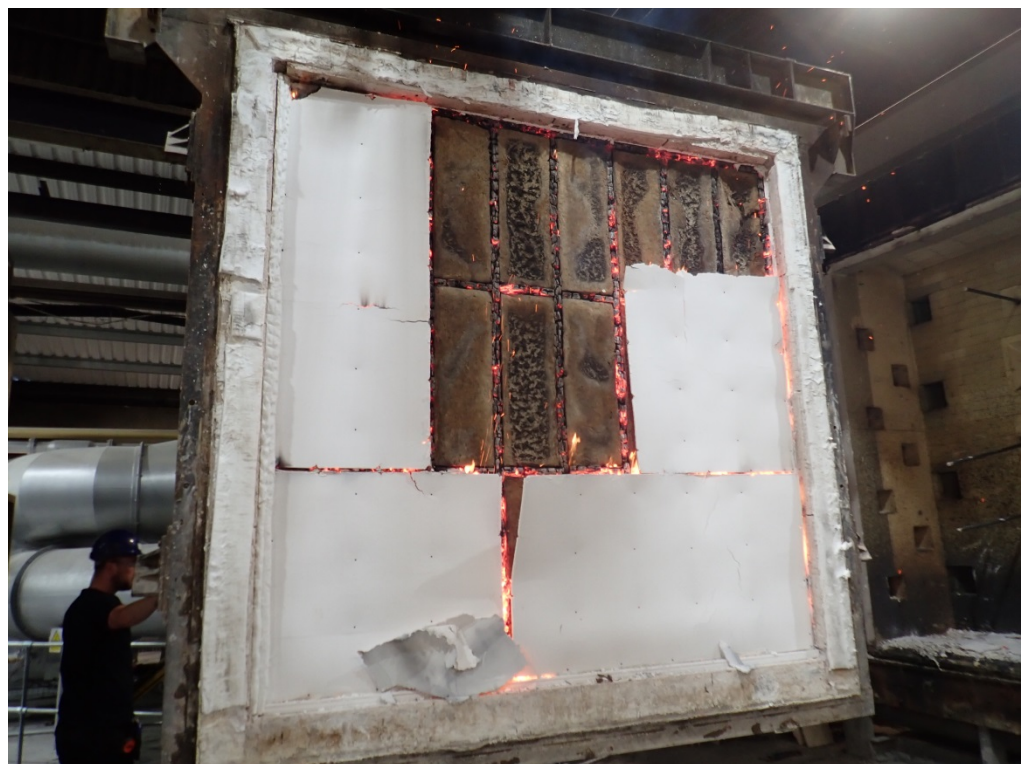
The exposed face of the specimen immediately after the test

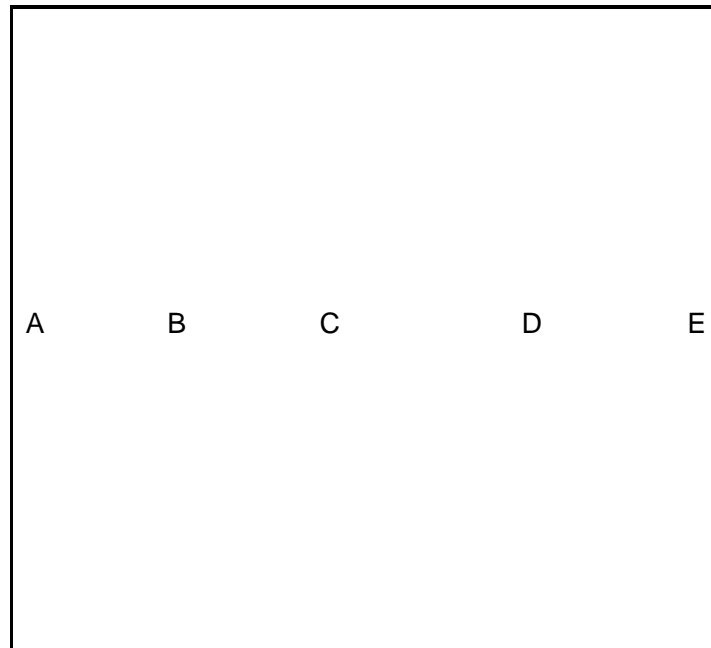
Deflections Of The Specimen During The Test

TIME mins	Deflections - mm				
	A	B	C	D	E
0	0	0	0	0	0
5	-2	-2	0	0	-5
10	-2	-2	-2	-2	-2
15	-1	-3	-3	-3	-3
20	-2	-6	-5	-3	-3
25	0	-9	-8	-4	-2
30	0	-8	-6	-4	-7
35	0	-8	-6	-3	-3
40	-2	-11	-7	-5	-7
45	-1	-12	-11	-8	-5
50	0	-14	-9	-9	-6
55	-1	-17	-14	-11	-5
60	-1	-19	-18	-9	-9
65	2	-24	-19	-12	-5

Positive values indicate a deflection towards the heating conditions of the test.
Measurements in mm

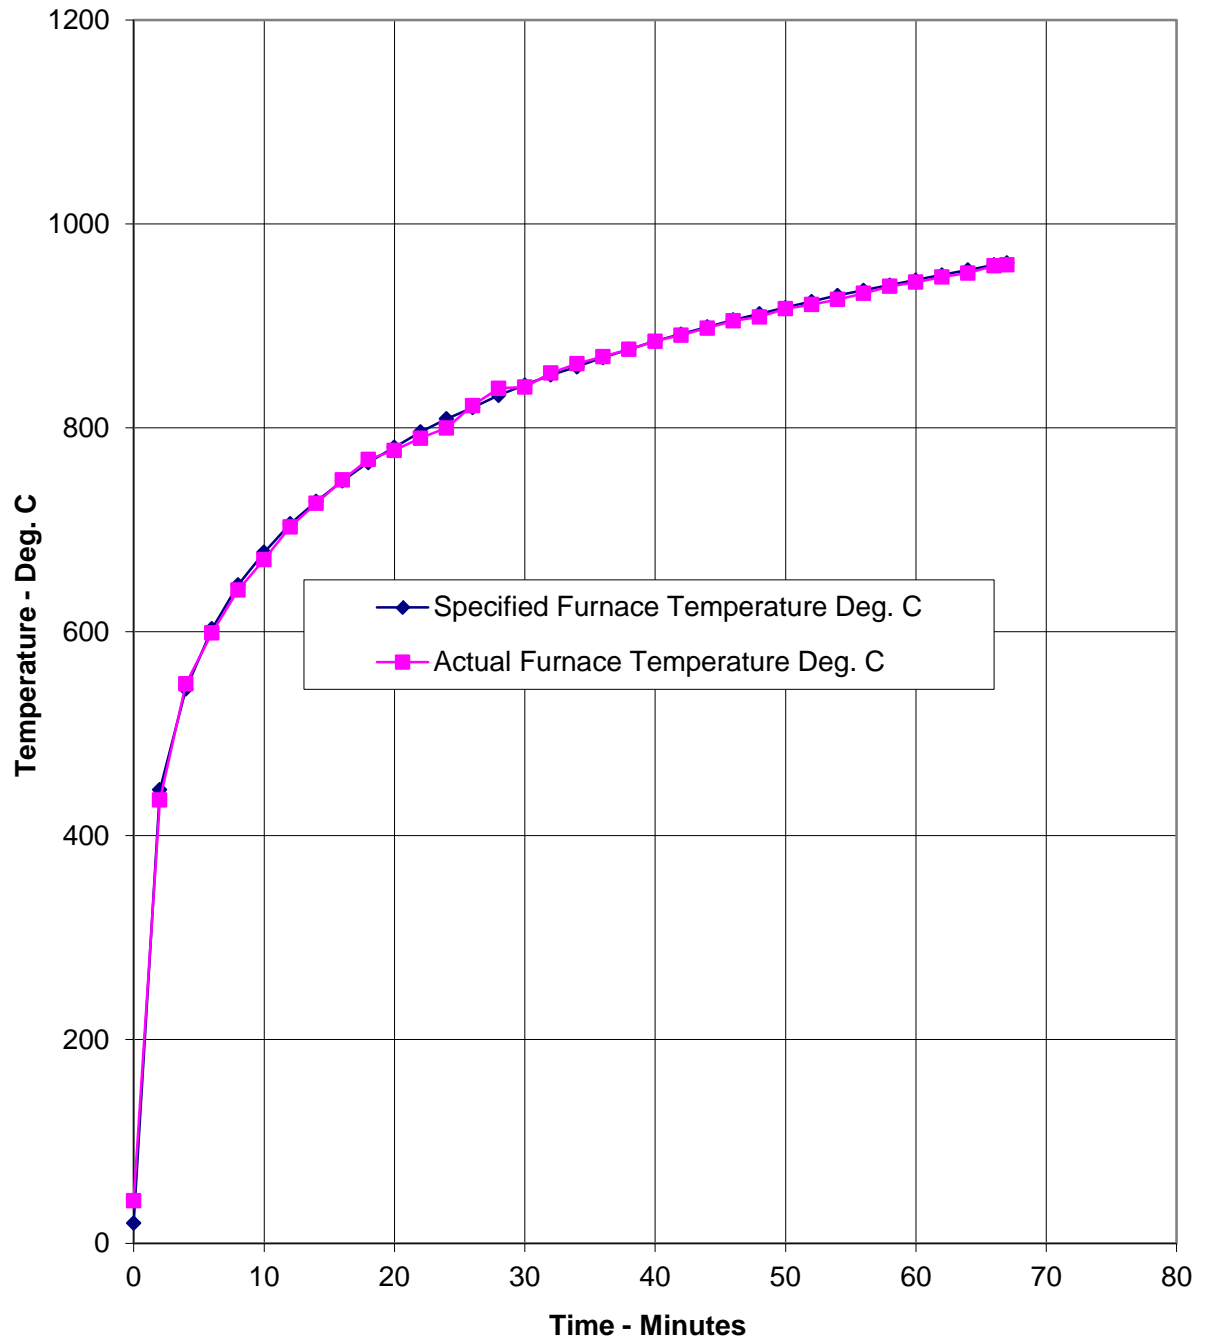
Graph Showing Mean Furnace Temperature, Together With The Temperature/Time Relationship Specified In BS 476 Part 20

Time Mins	Specified Furnace Temperature Deg. C	Actual Furnace Temperature Deg. C
0	20	42
2	445	435
4	544	549
6	603	599
8	646	641
10	678	671
12	706	703
14	728	726
16	748	749
18	766	769
20	781	778
22	796	790
24	809	800
26	820	822
28	832	839
30	842	840
32	852	854
34	860	863
36	869	870
38	877	877
40	885	885
42	892	891
44	899	898
46	906	905
48	912	909
50	918	917
52	924	921
54	930	926
56	935	932
58	940	939
60	945	943
62	950	948
64	955	952
66	960	959
67	962	960

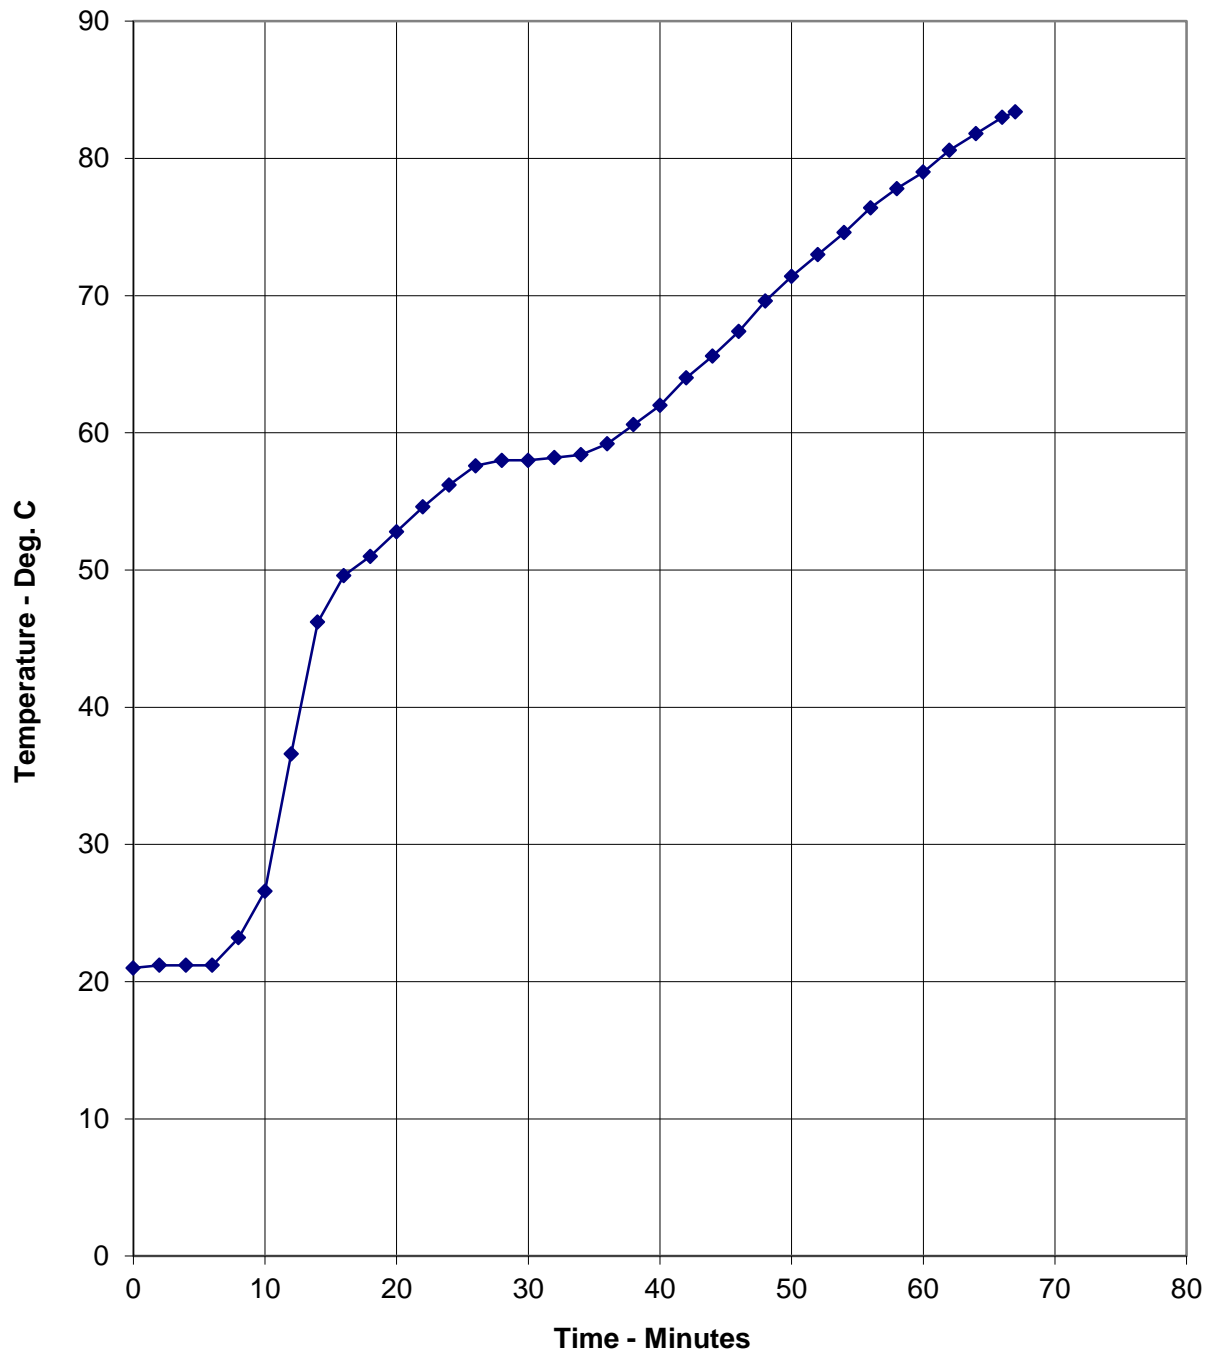
Graph Showing Mean Temperatures Recorded On The Unexposed Surface

Time Mins	T/C Number 4 Deg. C	T/C Number 5 Deg. C	T/C Number 6 Deg. C	T/C Number 7 Deg. C	T/C Number 8 Deg. C	Mean Temp Deg. C
0	21	21	21	22	20	21
2	21	22	21	22	20	21
4	21	22	21	22	20	21
6	21	22	21	22	20	21
8	22	26	23	24	21	23
10	26	32	25	29	21	27
12	33	44	36	48	22	37
14	38	53	54	62	24	46
16	41	56	58	66	27	50
18	43	56	60	67	29	51
20	46	57	62	68	31	53
22	48	58	64	70	33	55
24	49	58	67	71	36	56
26	50	59	69	71	39	58
28	50	59	69	71	41	58
30	50	58	69	71	42	58
32	51	57	69	71	43	58
34	51	56	68	72	45	58
36	52	56	68	74	46	59
38	54	57	69	75	48	61
40	56	57	69	78	50	62
42	59	58	70	80	53	64
44	61	60	70	82	55	66
46	63	61	71	84	58	67
48	65	63	72	87	61	70
50	67	65	72	89	64	71
52	68	66	73	91	67	73
54	70	67	74	93	69	75
56	71	69	75	95	72	76
58	72	70	76	97	74	78
60	74	71	76	98	76	79
62	75	73	77	99	79	81
64	76	74	78	100	81	82
66	78	75	79	100	83	83
67	78	76	79	100	84	83

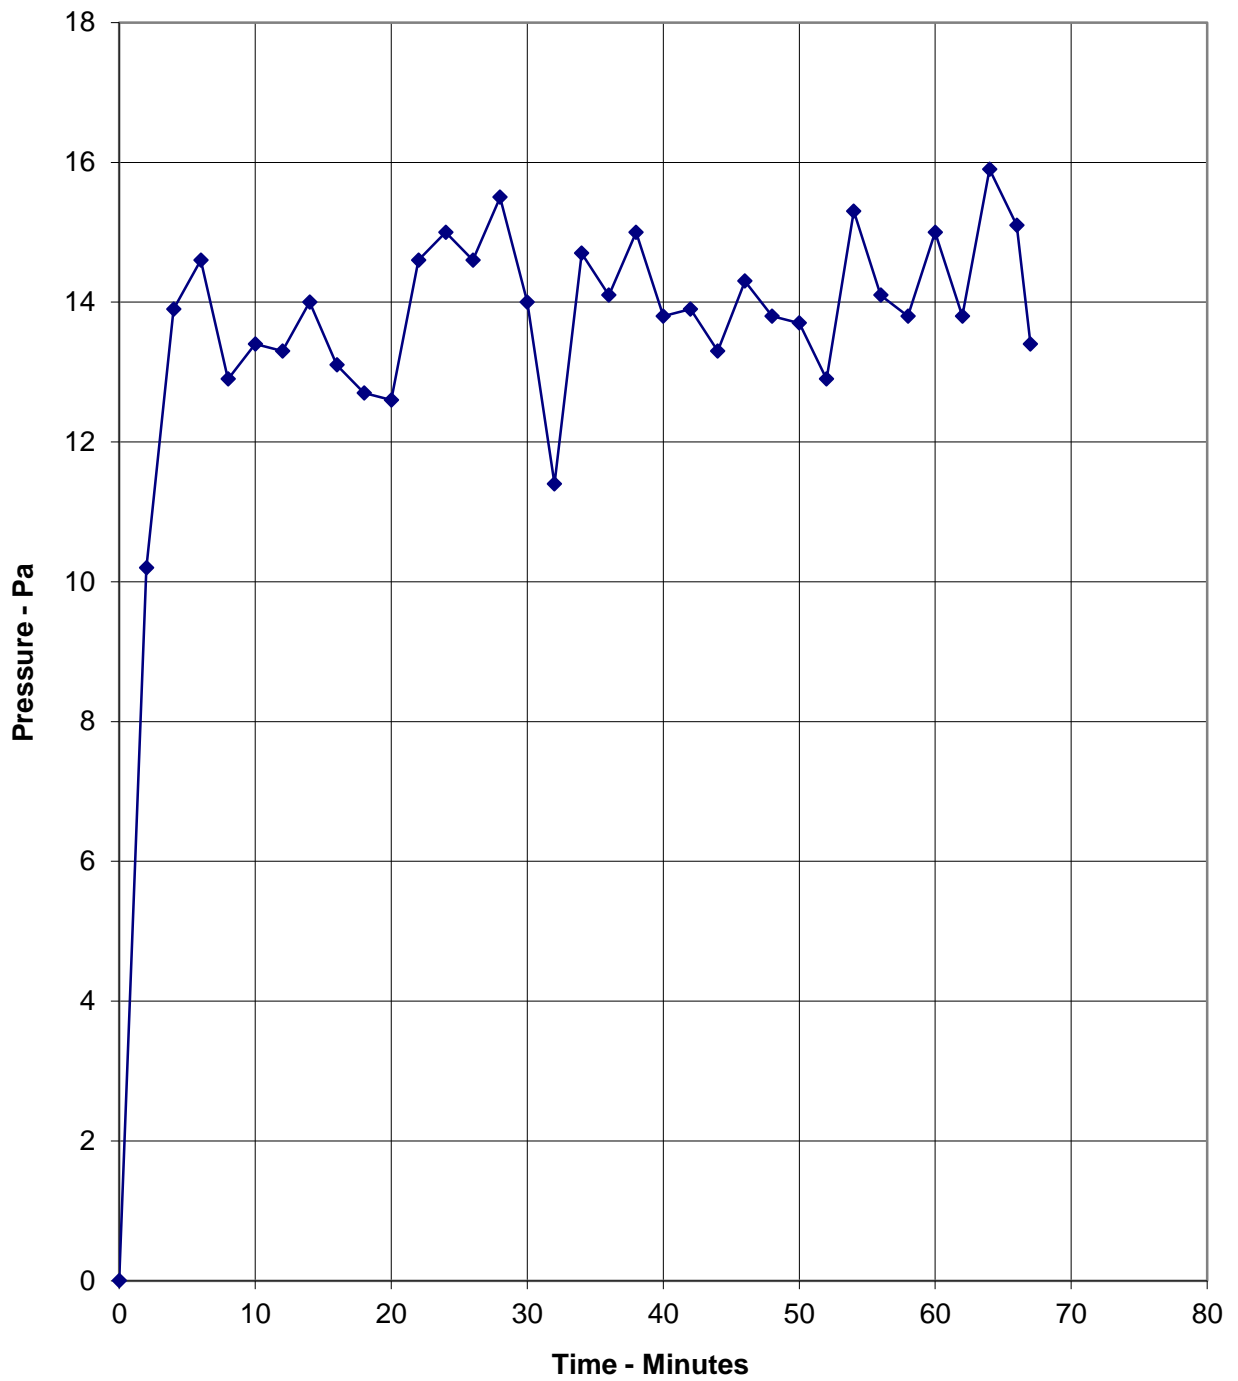
Graph Showing The Recorded Pressure 300 mm Below The Head Of The Specimen

Ambient Temperature	The ambient air temperature in the vicinity of the test construction was 22°C at the start of the test with a maximum variation of -1°C during the test.
Furnace	The furnace was controlled so that its mean temperature complied with the requirements of BS 476: Part 20: 1987, Clause 3.1. using nine mineral insulated thermocouples distributed over a plane 100 mm from the surface of the test construction.
Thermocouples	Thermocouples were provided to monitor the unexposed surface of the specimen. The output of all instrumentation was recorded at no less than one minute intervals. The locations and reference numbers of the various unexposed surface thermocouples are shown in Figure 1.
Furnace Pressure	After the first five minutes of testing and for the remainder of the test, the furnace atmospheric pressure was controlled so that it complied with the requirements of BS 476: Part 20: 1987, Clause 3.2.2 (including allowance for transient occurrences in-line with Clause 12(I)). The calculated pressure differential relative to the laboratory atmosphere at the top of the assembly was 17 (± 2) Pa equating to 0 Pa at a point 1m above the notional floor level.
